CLOSURE AND RECLAMATION WORK RECORD

Lease	EL 2367	Project Area	Pegasus, South DBS/GTS Haul Road		Costean ID	A2C0001
Title: A2C0001 Closure Report						
Pre-Rehab Condition	As per Before photographs. Overgrown, some minor erosion.					
Method Of Work and Equipment Used	Excavator and skid steer where used. The Costean was backfilled using excavator from the spoil line and the site was levelled, scarified and spread with vegetation where ever possible using the skid steers and where possible all signs of interference where removed such as wheel tracks.					
Hazards / Risks	Trench cave in. Regrowth of vegetation both in the trench and within the spoil.					
Permit Required?	Yes	Permit type	SDP	Permit number	2020-43/2021-47	
Other Notes	Surface Works completed the works					
Materials, Quantities and Costs	Spoil adjacent to the costean was used. There was some vegetation growing in the spoil and in the costean. This will regrowth from the trench.

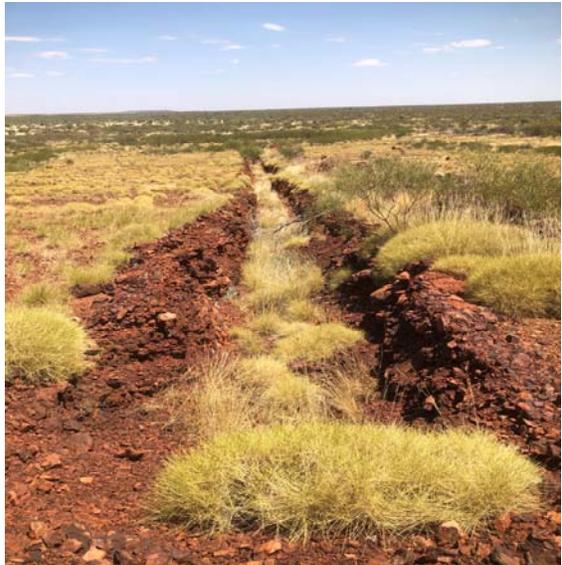
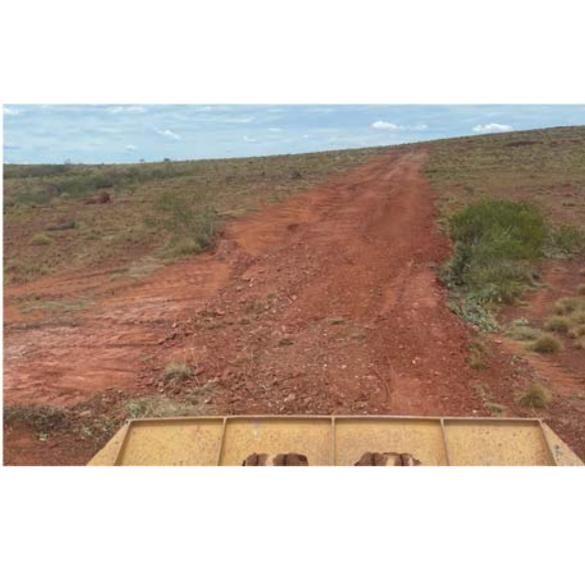
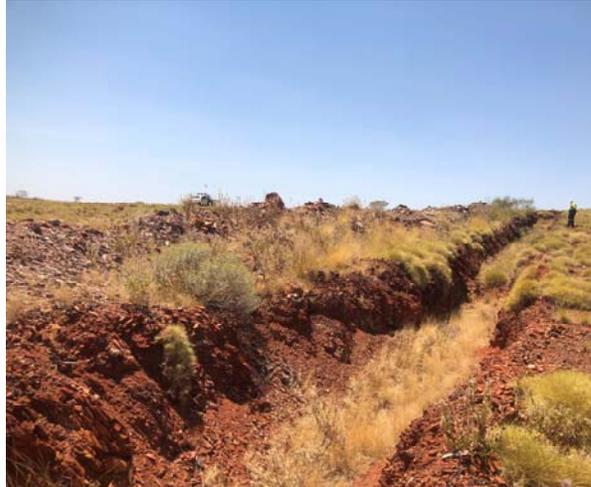
Lease	EL 2367	Project Area	Schist Hills, South east of DBS		Costean ID	SCH0007
Title: SCH007 Closure Report						
Pre-Rehab Condition	As per Before photographs. Overgrown, some minor erosion.					
Method Of Work and Equipment Used	Excavator and skid steer where used. The Costean was backfilled using excavator from the spoil line and the site was levelled, scarified and spread with vegetation where ever possible using the skid steers and where possible all signs of interference where removed such as wheel tracks.					
Hazards / Risks	Trench cave in. Regrowth of vegetation both in the trench and within the spoil.					
Permit Required?	Yes	Permit type	SDP	Permit number	2020-43/2021-47	
Other Notes	Surface Works completed the works					
Materials, Quantities and Costs	Spoil adjacent to the costean was used. There was some vegetation growing in the spoil and in the costean. This will regrowth from the trench.

Opportunities	Inspect the works after 12 months to assess the success of the works.					
Task Responsibility	Task Completion Status	Operator Sign-Off			Date	
Surface Works	Completed	-			15/01/2022	
		Supervisor Sign-Off			Date

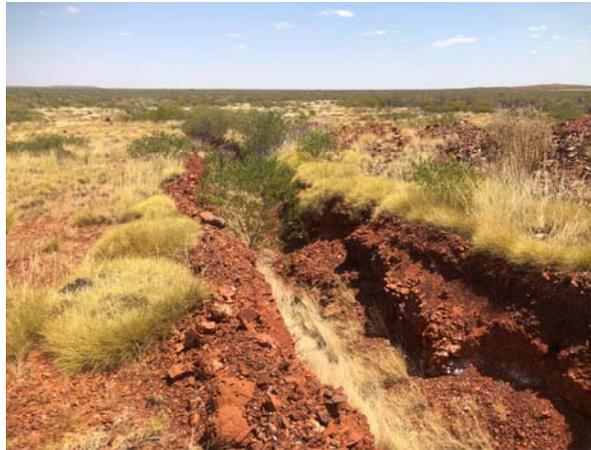
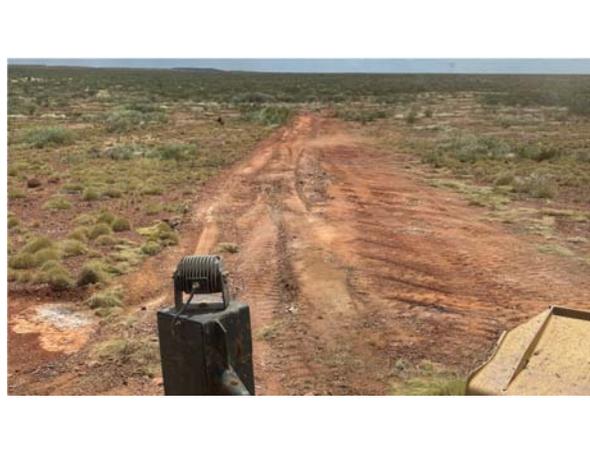
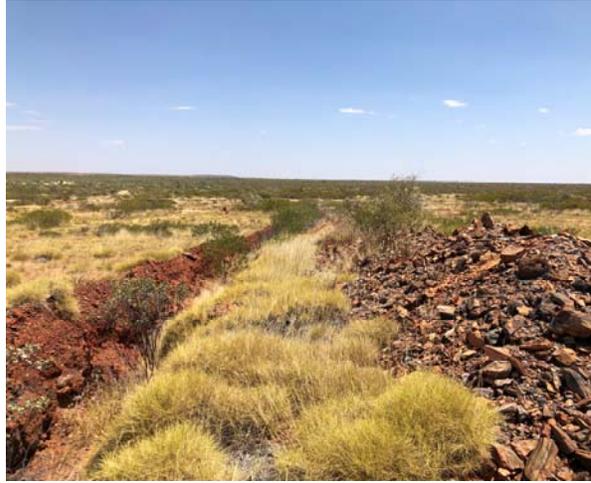
Lease	EL 2367	Project Area	Schist Hills, South east of DBS		Costean ID	SCH0006
Title: SCH0006 Closure Report						
Pre-Rehab Condition	As per Before photographs. Overgrown, some minor erosion.					
Method Of Work and Equipment Used	Excavator and skid steer where used. The Costean was backfilled using excavator from the spoil line and the site was levelled, scarified and spread with vegetation where ever possible using the skid steers and where possible all signs of interference where removed such as wheel tracks.					
Hazards / Risks	Trench cave in. Regrowth of vegetation both in the trench and within the spoil.					
Permit Required?	Yes	Permit type	SDP	Permit number	2020-43/2021-47	
Other Notes	Surface Works completed the works					
Materials, Quantities and Costs	Spoil adjacent to the costean was used. There was some vegetation growing in the spoil and in the costean. This will regrowth from the trench.

Opportunities	Inspect the works after 12 months to assess the success of the works.					
Task Responsibility	Task Completion Status	Operator Sign-Off			Date	
Surface Works	Completed	-			15/01/2022	
		Supervisor Sign-Off			Date

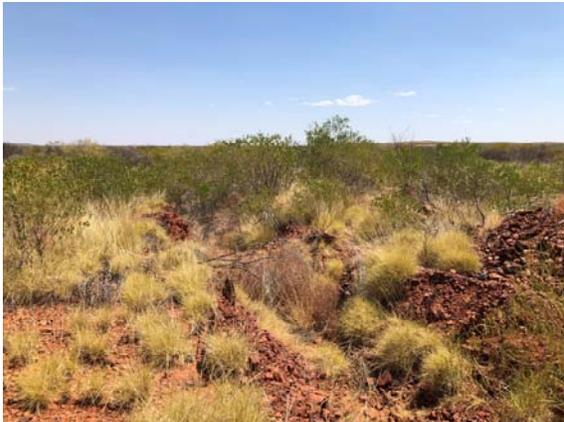
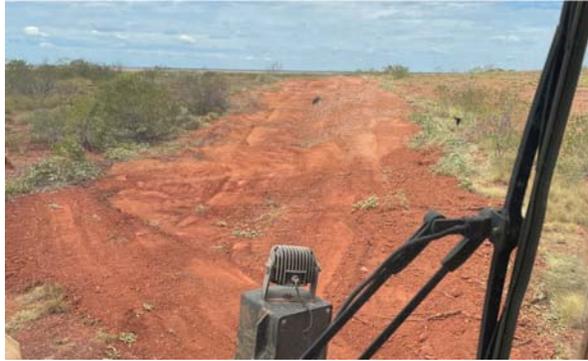
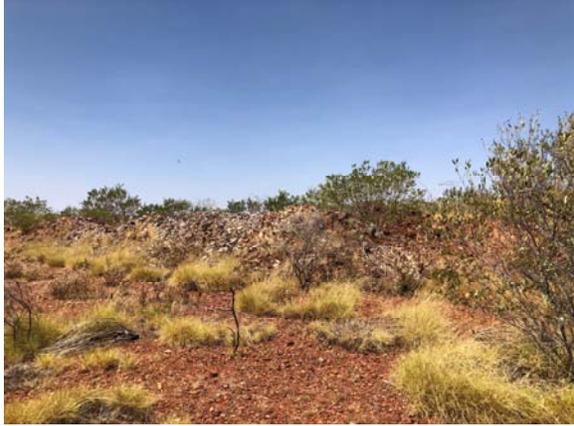
Lease	EL 2367	Project Area	Schist Hills, South east of DBS		Costean ID	SCH0005
Title: SCH0005 Closure Report						
Pre-Rehab Condition	As per Before photographs. Overgrown, some minor erosion.					
Method Of Work and Equipment Used	Excavator and skid steer where used. The Costean was backfilled using excavator from the spoil line and the site was levelled, scarified and spread with vegetation where ever possible using the skid steers and where possible all signs of interference where removed such as wheel tracks.					
Hazards / Risks	Trench cave in. Regrowth of vegetation both in the trench and within the spoil.					
Permit Required?	Yes	Permit type	SDP	Permit number	2020-43/2021-47	
Other Notes	Surface Works completed the works					
Materials, Quantities and Costs	Spoil adjacent to the costean was used. There was some vegetation growing in the spoil and in the costean. This will regrowth from the trench.

Opportunities	Inspect the works after 12 months to assess the success of the works.					
Task Responsibility	Task Completion Status	Operator Sign-Off			Date	
Surface Works	Completed	-			15/01/2022	
		Supervisor Sign-Off			Date

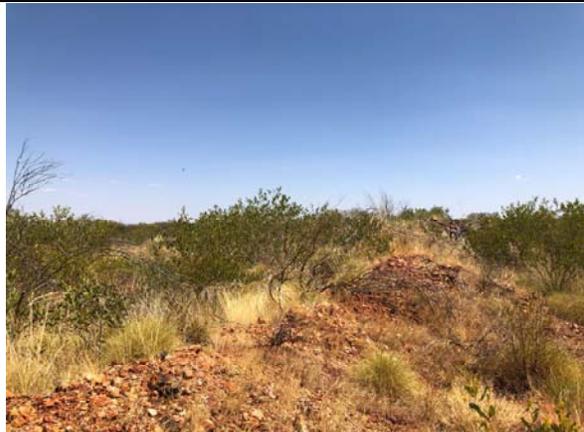
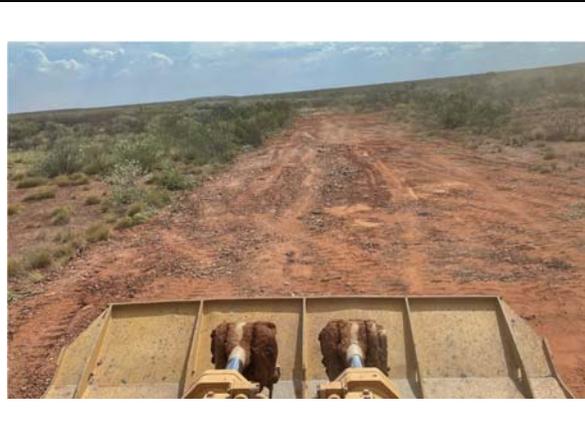
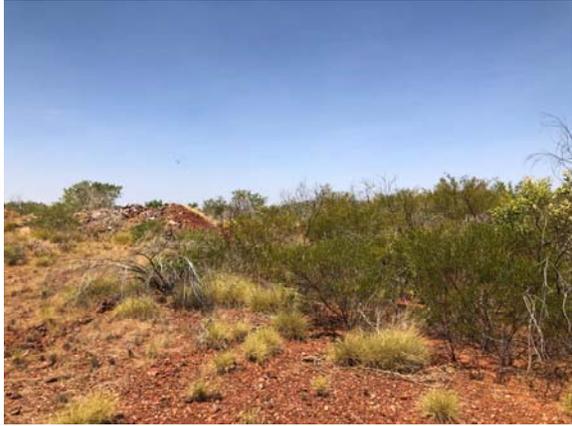
Lease	EL 2367	Project Area	SCHIST HILLS	Costean ID	SCH0004
Title: SCH004 Closure Report					
Pre-Rehab Condition	As per Before photographs. Overgrown, some minor erosion.				
Method Of Work and Equipment Used	Excavator and skid steer where used. The Costean was backfilled using excavator from the spoil line and the site was levelled, scarified and spread with vegetation where ever possible using the skid steers and where possible all signs of interference where removed such as wheel tracks.				
Hazards / Risks	Trench cave in. Regrowth of vegetation both in the trench and within the spoil.				
Permit Required?	Yes	Permit type	SDP	Permit number	2020-43/2021-47
Other Notes	Surface Works completed the works				
Materials, Quantities and Costs	Spoil adjacent to the costean was used. There was some vegetation growing in the spoil and in the costean. This will regrowth from the trench.				
Opportunities	Inspect the works after 12 months to assess the success of the works.

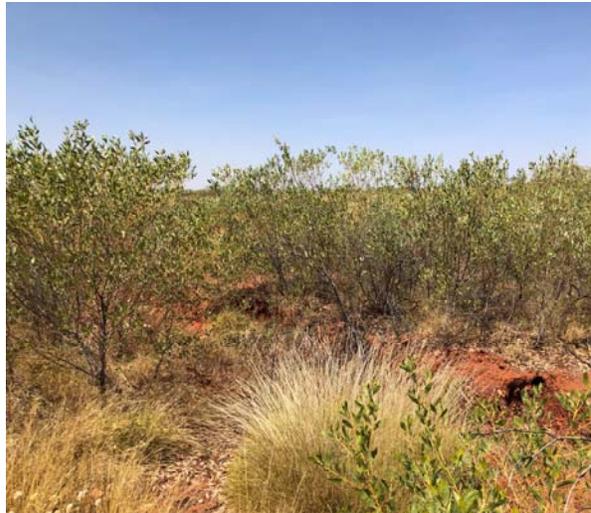
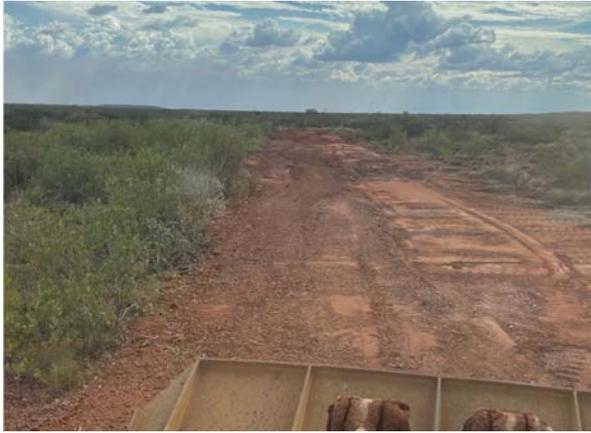
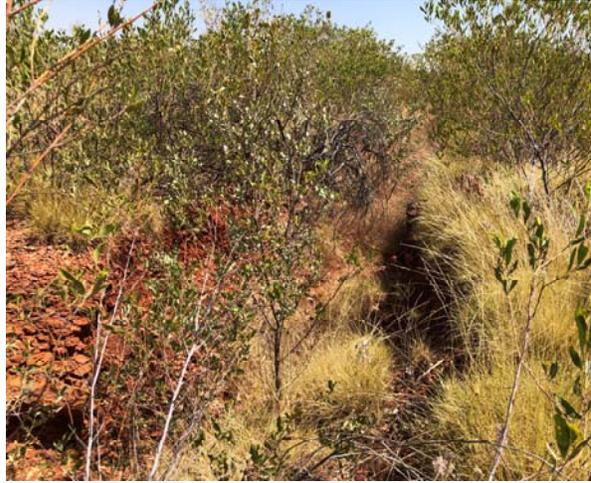
Lease	EL 2367	Project Area	SCHIST HILLS		Costean ID	SCH0003
Title: SCH0003 Closure Report						
Pre-Rehab Condition	As per Before photographs. Overgrown, some minor erosion.					
Method Of Work and Equipment Used	Excavator and skid steer where used. The Costean was backfilled using excavator from the spoil line and the site was levelled, scarified and spread with vegetation where ever possible using the skid steers and where possible all signs of interference where removed such as wheel tracks.					
Hazards / Risks	Trench cave in. Regrowth of vegetation both in the trench and within the spoil.					
Permit Required?	Yes	Permit type	SDP	Permit number	2020-43/2021-47	
Other Notes	Surface Works completed the works					
Materials, Quantities and Costs	Spoil adjacent to the costean was used. There was some vegetation growing in the spoil and in the costean. This will regrowth from the trench.					
Opportunities	Inspect the works after 12 months to assess the success of the works.

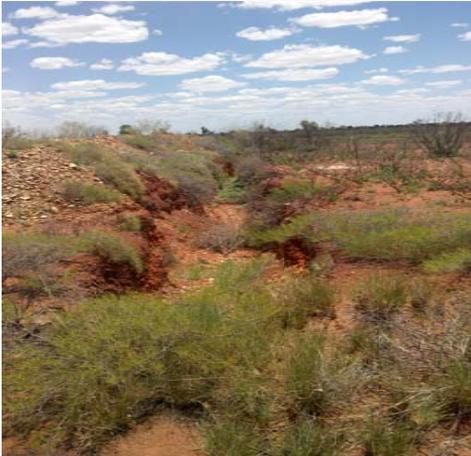
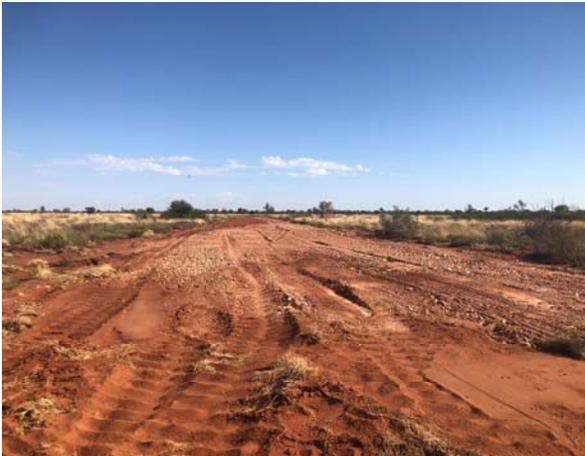
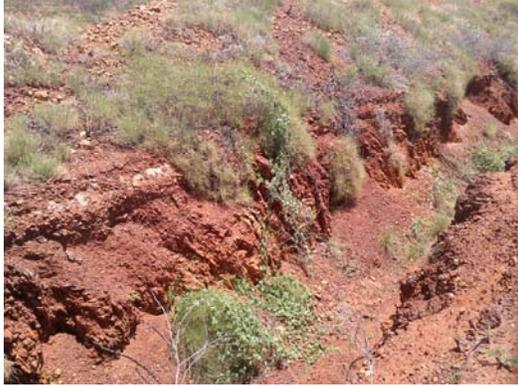
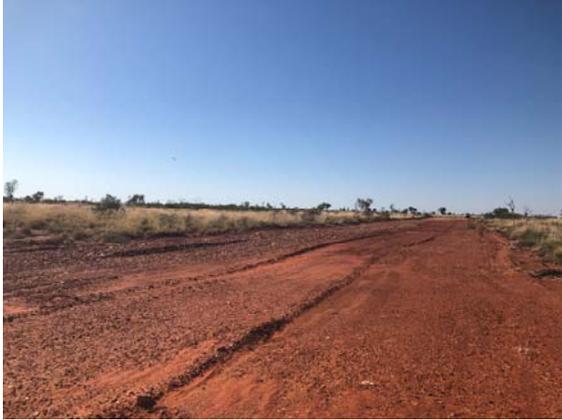
Lease	EL 2367	Project Area	Pegasus, South DBS/GTS Haul Road		Costean ID	A2C0007
Title: A2C0007 Closure Report						
Pre-Rehab Condition	As per Before photographs. Overgrown, some minor erosion.					
Method Of Work and Equipment Used	Excavator and skid steer where used. The Costean was backfilled using excavator from the spoil line and the site was levelled, scarified and spread with vegetation where ever possible using the skid steers and where possible all signs of interference where removed such as wheel tracks.					
Hazards / Risks	Trench cave in. Regrowth of vegetation both in the trench and within the spoil.					
Permit Required?	Yes	Permit type	SDP	Permit number	2020-43/2021-47	
Other Notes	Surface Works completed the works					
Materials, Quantities and Costs	Spoil adjacent to the costean was used. There was some vegetation growing in the spoil and in the costean. This will regrowth from the trench.

Opportunities	Inspect the works after 12 months to assess the success of the works.					
Task Responsibility	Task Completion Status	Operator Sign-Off			Date	
Surface Works	Completed	-			6/12/21	
		Supervisor Sign-Off			Date

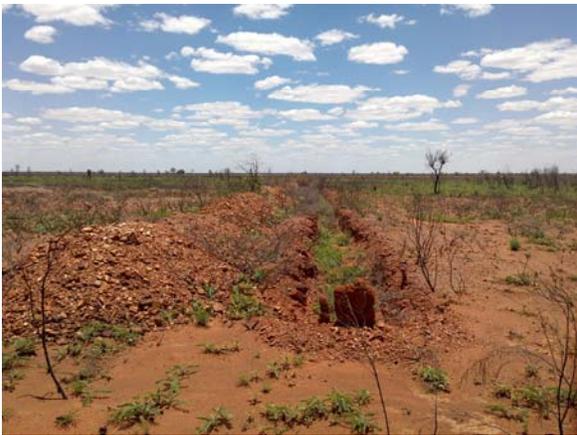
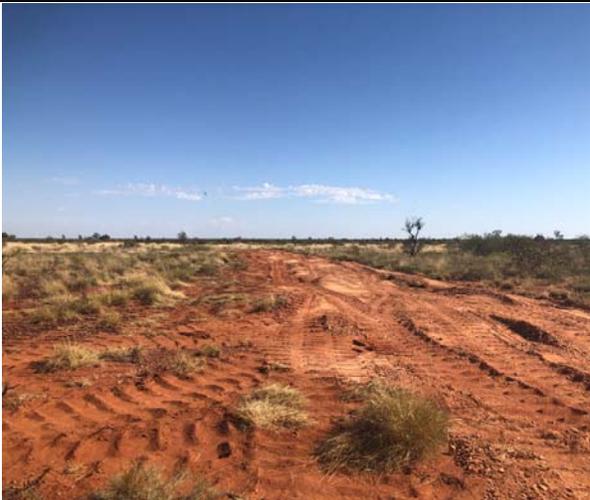
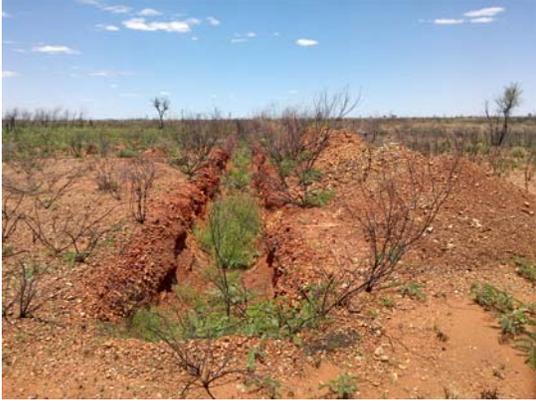
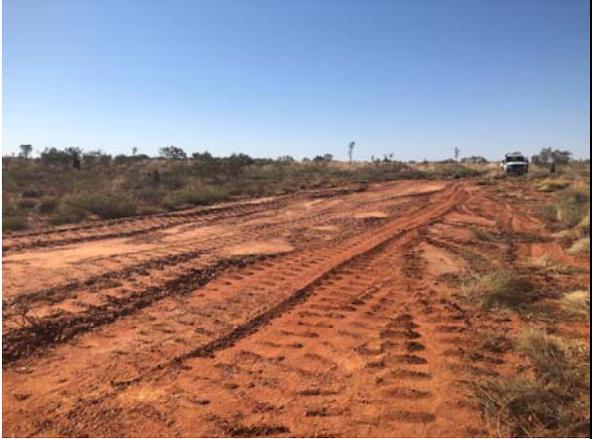
Lease	EL 23660	Project Area	PEGASUS		Costean ID	A2C0004
Title: A2C0004 Closure Report						
Pre-Rehab Condition	As per Before photographs. Overgrown, some minor erosion.					
Method Of Work and Equipment Used	Excavator and skid steer where used. The Costean was backfilled using excavator from the spoil line and the site was levelled, scarified and spread with vegetation where ever possible using the skid steers and where possible all signs of interference where removed such as wheel tracks.					
Hazards / Risks	Trench cave in. Regrowth of vegetation both in the trench and within the spoil.					
Permit Required?	Yes	Permit type	SDP	Permit number	2020-43/2021-47	
Other Notes	Surface Works completed the works					
Materials, Quantities and Costs	Spoil adjacent to the costean was used. There was some vegetation growing in the spoil and in the costean. This will regrowth from the trench.					
Opportunities	Inspect the works after 12 months to assess the success of the works.

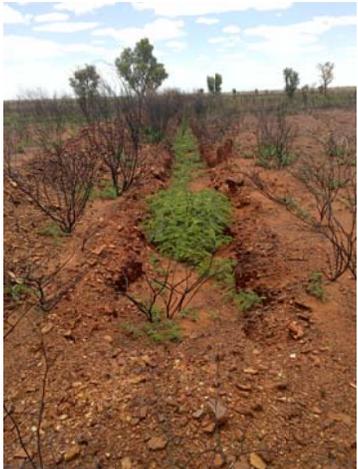
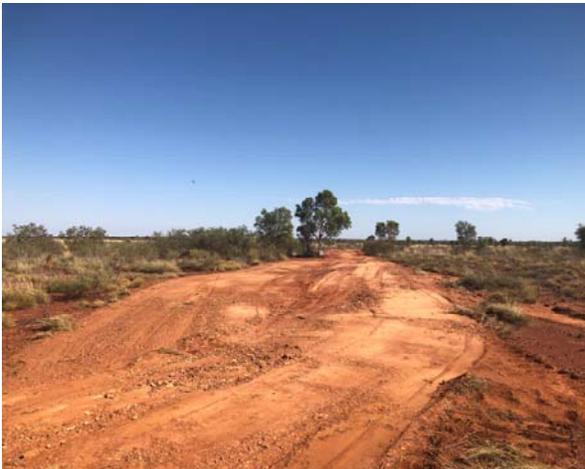
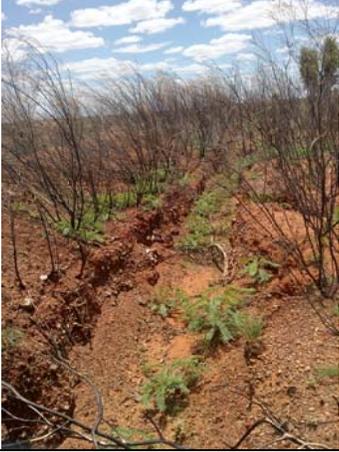
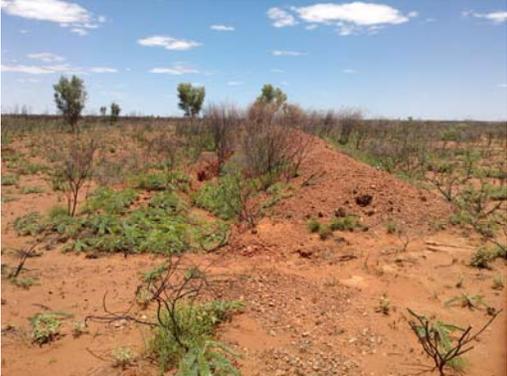
Lease	EL 23660	Project Area	Pegasus, South DBS/GTS Haul Road		Costean ID	A2C0003
Title: A2C0003 Closure Report						
Pre-Rehab Condition	As per Before photographs. Overgrown, some minor erosion.					
Method Of Work and Equipment Used	Excavator and skid steer where used. The Costean was backfilled using excavator from the spoil line and the site was levelled, scarified and spread with vegetation where ever possible using the skid steers and where possible all signs of interference where removed such as wheel tracks.					
Hazards / Risks	Trench cave in. Regrowth of vegetation both in the trench and within the spoil.					
Permit Required?	Yes	Permit type	SDP	Permit number	2020-43/2021-47	
Other Notes	Surface Works completed the works					
Materials, Quantities and Costs	Spoil adjacent to the costean was used. There was some vegetation growing in the spoil and in the costean. This will regrowth from the trench.

Opportunities	Inspect the works after 12 months to assess the success of the works.					
Task Responsibility	Task Completion Status	Operator Sign-Off			Date	
Surface Works	Completed	-			6/12/21	
		Supervisor Sign-Off			Date

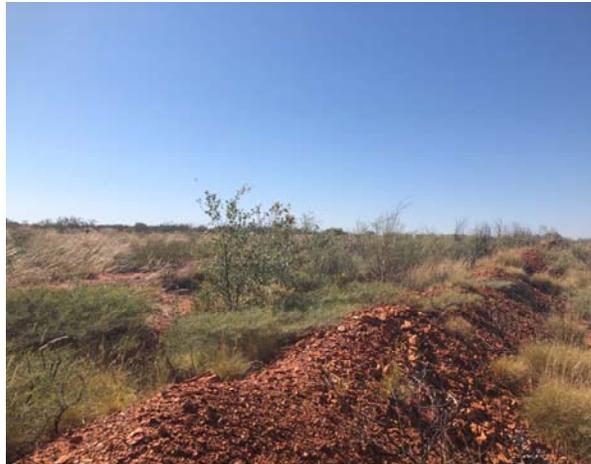
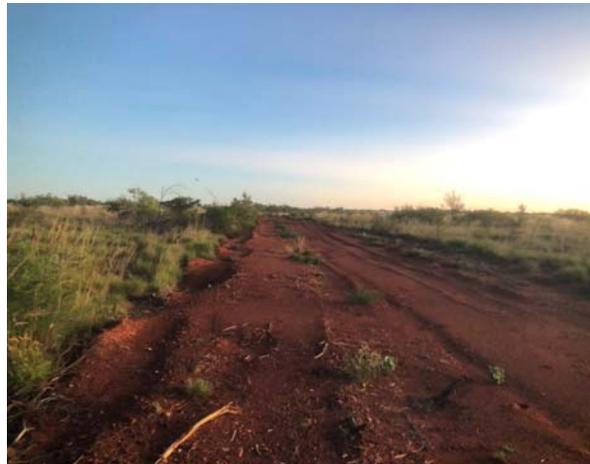
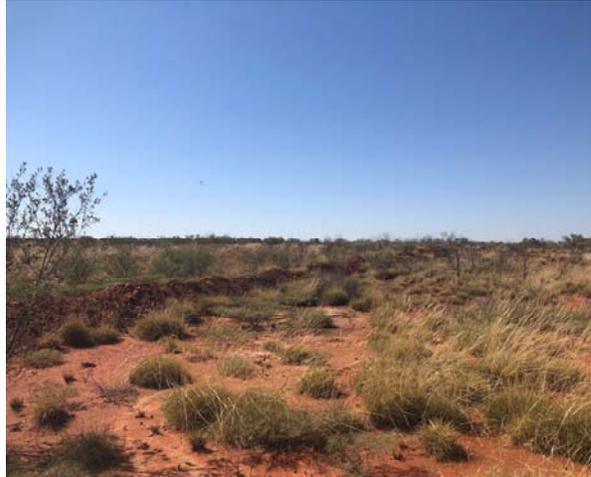
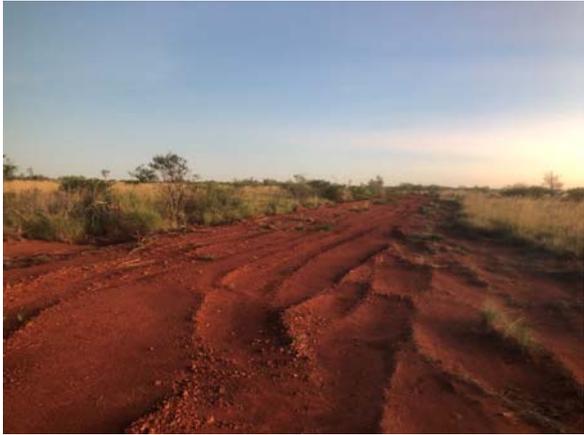
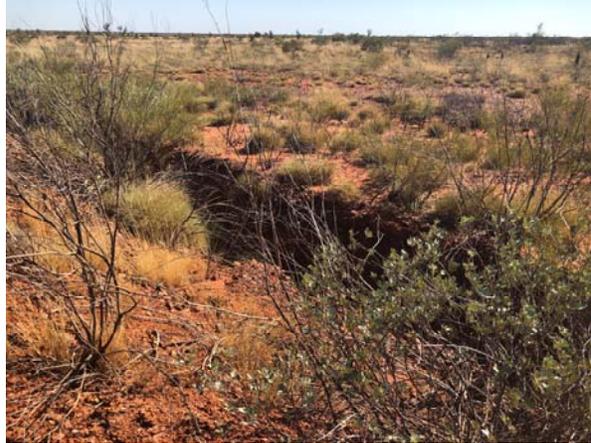
Lease	EL 23660	Project Area	Pegasus, South DBS/GTS Haul Road		Costean ID	A2C0002
Title: A2C0002 Closure Report						
Pre-Rehab Condition	As per Before photographs. Overgrown, some minor erosion.					
Method Of Work and Equipment Used	Excavator and skid steer where used. The Costean was backfilled using excavator from the spoil line and the site was levelled, scarified and spread with vegetation where ever possible using the skid steers and where possible all signs of interference where removed such as wheel tracks.					
Hazards / Risks	Trench cave in. Regrowth of vegetation both in the trench and within the spoil.					
Permit Required?	Yes	Permit type	SDP	Permit number	2020-43/2021-47	
Other Notes	Surface Works completed the works					
Materials, Quantities and Costs	Spoil adjacent to the costean was used. There was some vegetation growing in the spoil and in the costean. This will regrowth from the trench.

Opportunities	Inspect the works after 12 months to assess the success of the works.					
Task Responsibility	Task Completion Status	Operator Sign-Off			Date	
Surface Works	Completed	-			6/12/21	
		Supervisor Sign-Off			Date
