NORTHERN GAS PIPELINE

ENVIRONMENTAL COMPLIANCE PROGRESS REPORT

Report 1: Q3 2017

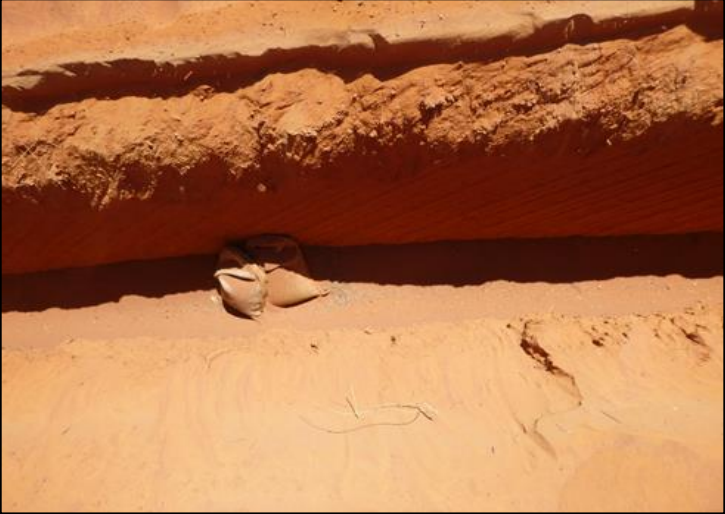
ACTION	MONITORING ACTIVITY	FINDING	RECOMMENDATION AND CONTINUOUS IMPROVEMENT	SUPPORTING EVIDENCE
<p>Biodiversity and Fauna Management</p>	<p>Fauna ramps and shelters have been used to meet compliance of the Biodiversity Management Plan and Trench Inspection Procedure that was approved during the EIS process to reduce the opportunity for fauna to fall into the trench and reducing fatalities by trench design and fauna management.</p> <p>Trench inspections were conducted while there was open trench between August and November 2017</p>	<p>A total of 11,749 fauna was recorded with a mortality rate of less than 6%.</p>	<p>Earth plugs are being placed within 1km intervals with slopes of less than 45° allowing fauna egress.</p> <p>An example of an in-trench fauna shelter is shown in Figure.1, which are being placed within 500m of each. These shelters are hessian sacks filled with sawdust and placed leaning against the wall of the trench, thereby allowing animals to hide beneath them.</p>

<p><i>Figure.1 - In-trench fauna shelters</i></p>

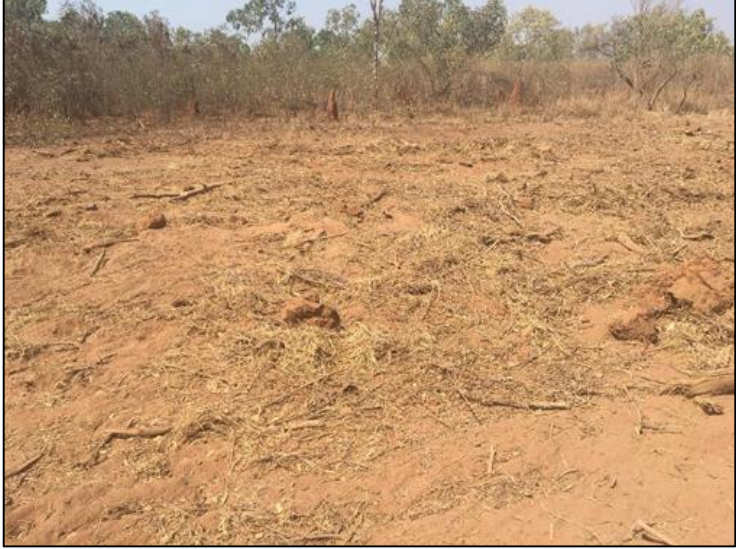
ACTION	MONITORING ACTIVITY	FINDING	RECOMMENDATION AND CONTINUOUS IMPROVEMENT	SUPPORTING EVIDENCE
<p>Reinstatement</p>	<p>Reinstatement is in progress along the ROW.</p>	<p>All trenching and backfilling complete for the first 262 km of the pipeline.</p> <p>Soil is being returned back into the trench with vegetation spread.</p> <p>An example is shown in Figure.2.</p>

<p><i>Figure.2 - Reinstatement of ROW</i></p>
