EXPLORATION OPERATIONS MINING MANAGEMENT PLAN AND PUBLIC REPORT

NORTHERN STAR (TANAMI) PTY LTD

CENTRAL TANAMI PROJECT

28 FEBRUARY 2017

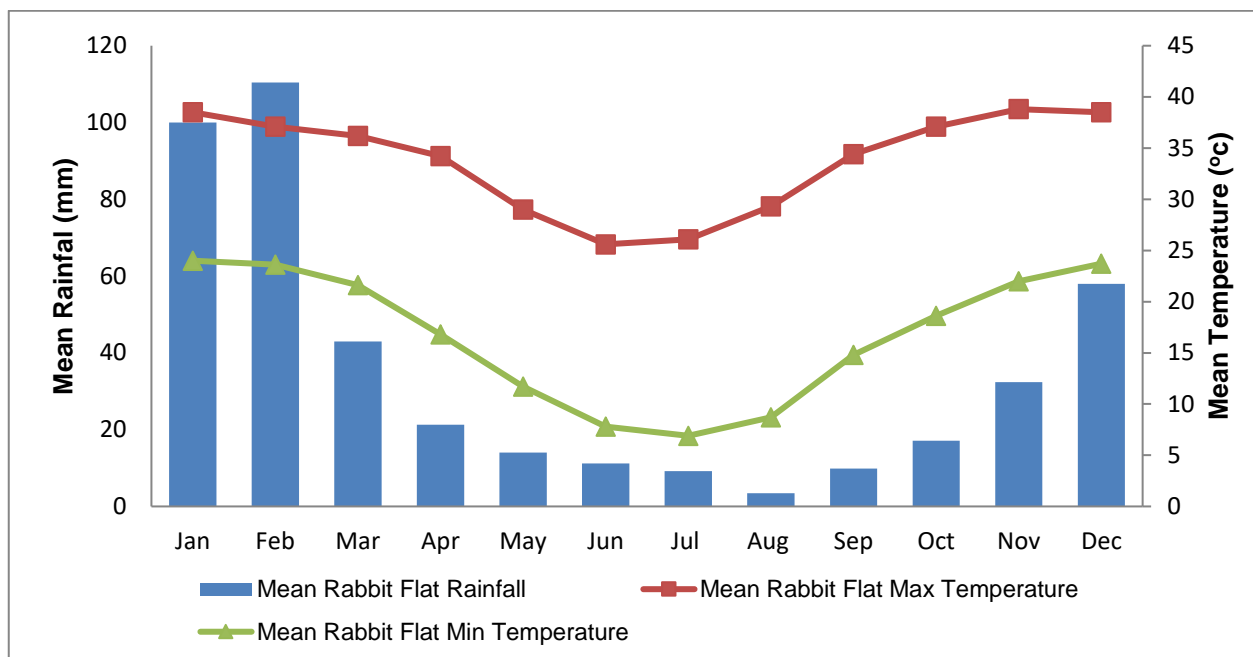
CTP has an average annual rainfall of 496.5mm determined from 15 years of weather data. The annual records at Rabbit Flat from 1996 to 2011 are presented in Figure 8 Mean Annual Rainfall and Temperature Rabbit Flat 1996-2011

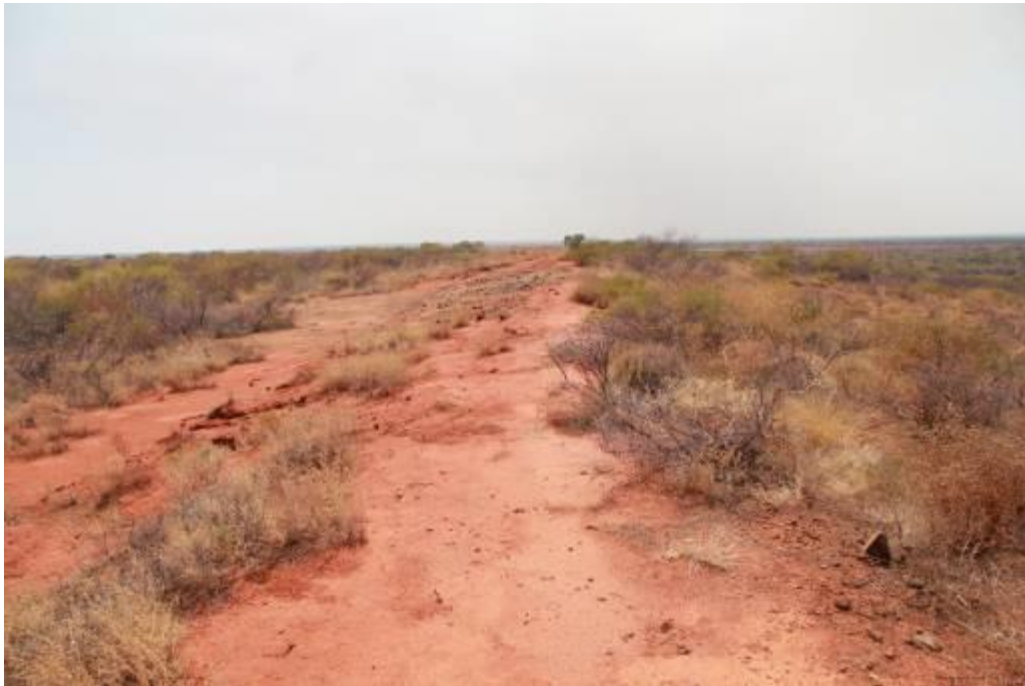
Figure 10 Groundrush Waste Dump Sediment Bund

The existing WRD is rehabilitated and internally draining. A bund is provided around the perimeter of the WRD that prevents water discharge (refer Figure 10).

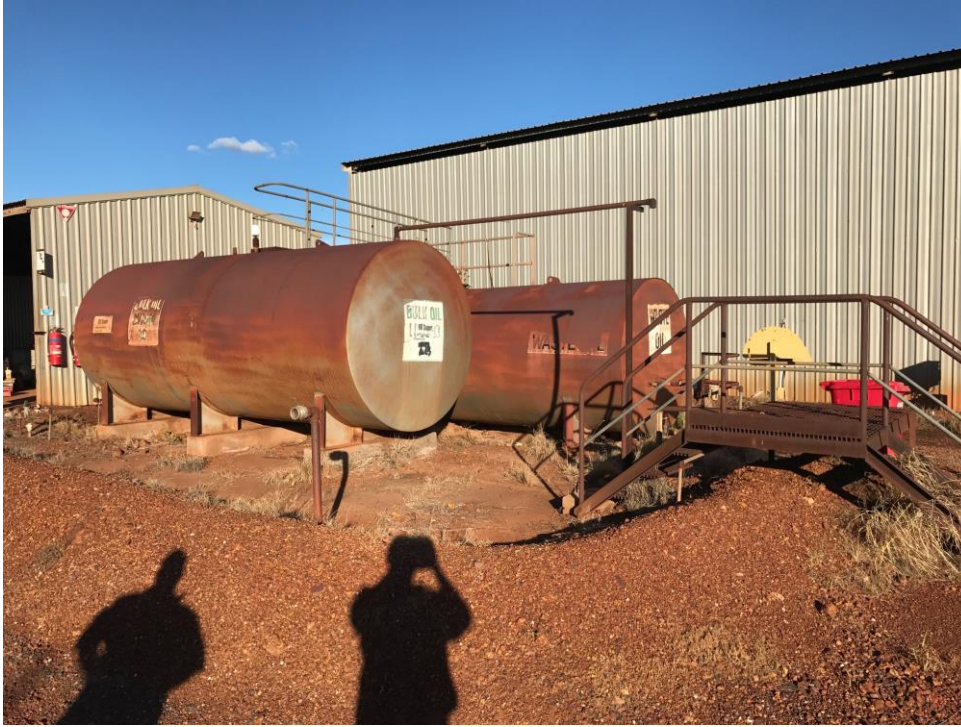
Figure 18 Bulk Oil / Waste Oil tanks.

As noted in Table 19, the bulk oil/waste oil area is subject to relatively minor contamination after many years of use. The oil storage tanks will be removed to the lay down area and hydrocarbon contaminated material will be removed to a bio-remediation area prior to the end of 2017. Details of a bio-remediation area will be submitted in a later MMP amendment when confirmed.
