**ROCKWASH PTY LTD**

**MINING MANAGEMENT PLAN (MMP)**

**Pine Creek Project**  
**(Exploration Only)**

EL31276, EL31313, EL31517, EL31524, EL31563, EL31632

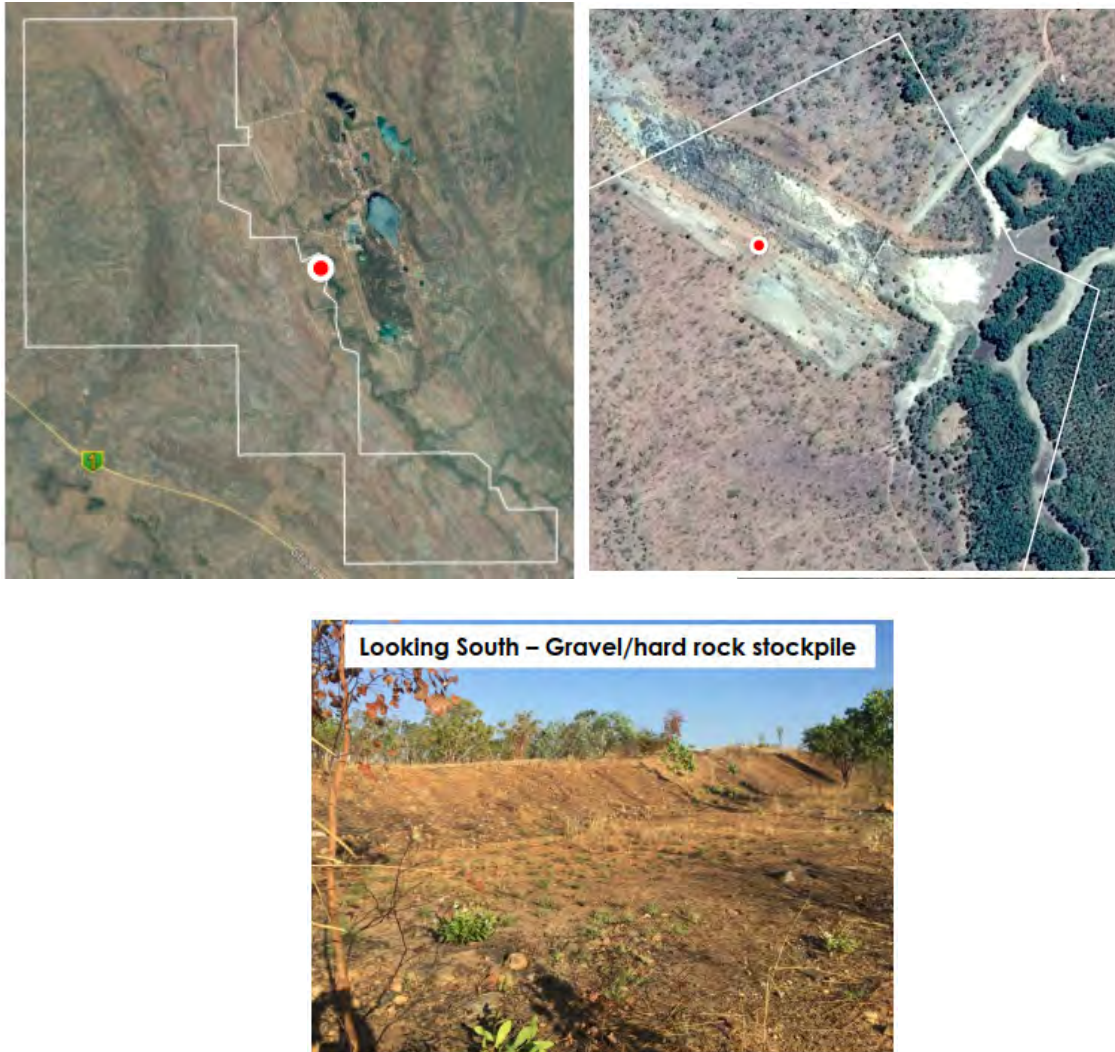
Of significance is a stockpile area at the middle eastern edge of the tenement, constructed during mining activity at Union Reef mines (figure below).

Figure 5 EL31313 adjacent to union reef mines, stockpile within EL31313, red dot is site photographed, white polygon is EL31313 boundary.

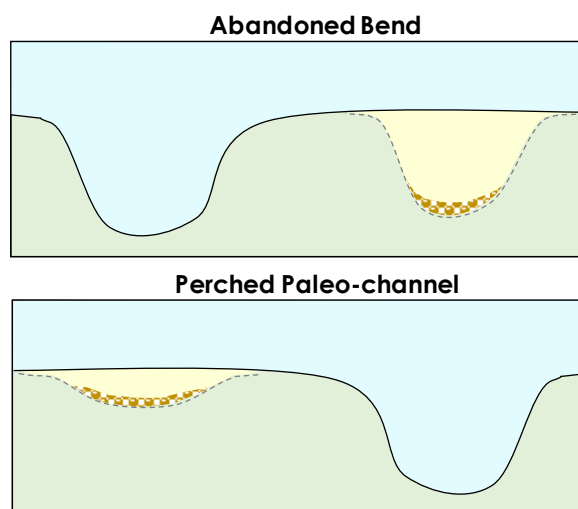
- Target paleo-drainage areas – likely more concentrated higher grades but greater overburden
- Target eluvial areas proximal to hard rock gold – likely lower grades but less overburden
- It should be noted that hard rock gold grades can be quite low (and uneconomic) but can still produce viable gold bearing gravels due to weathering and enrichment

Figure 6 Exploration Concept – Targeting Palaeo drainage areas not existing creeks.

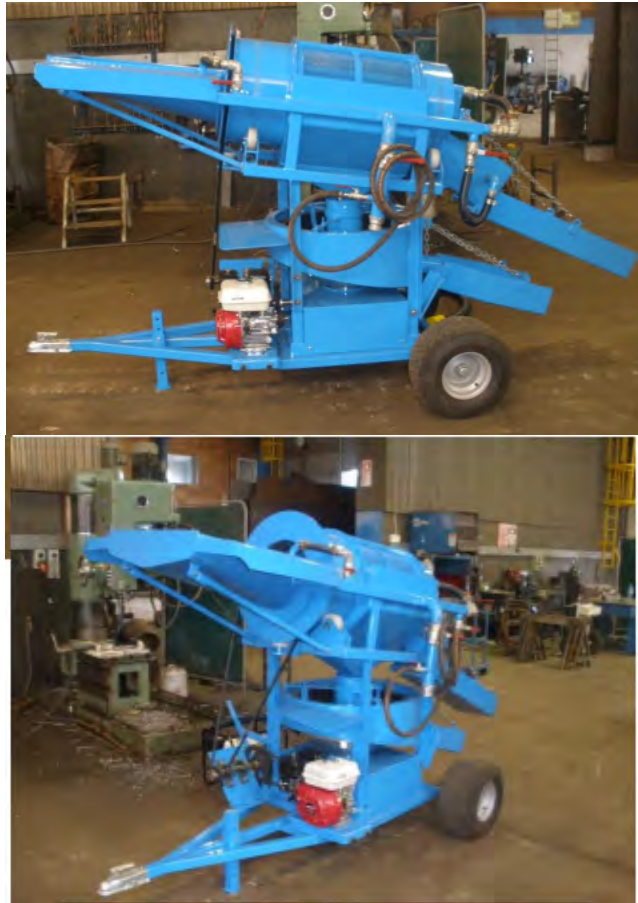
**Figure 7 Portable Testing Unit**

A sample of material (up to 24m<sup>3</sup>) – most likely 10m<sup>3</sup> from the deeper gravels - will be collected from each costean and positioned by the excavator at the corner of the pad. The sample will then be fed (with a 1.5t excavator) into the portable test sampler which includes a miniature hopper, trommel and centrifuge bowl (figure below).

The 2 sumps (5x3x1m per sump) will collect water runoff from the test unit. The first sump will enable settling of finer materials and will feed into the second sump which will be used for recycling water (similar to diamond drill sumps).

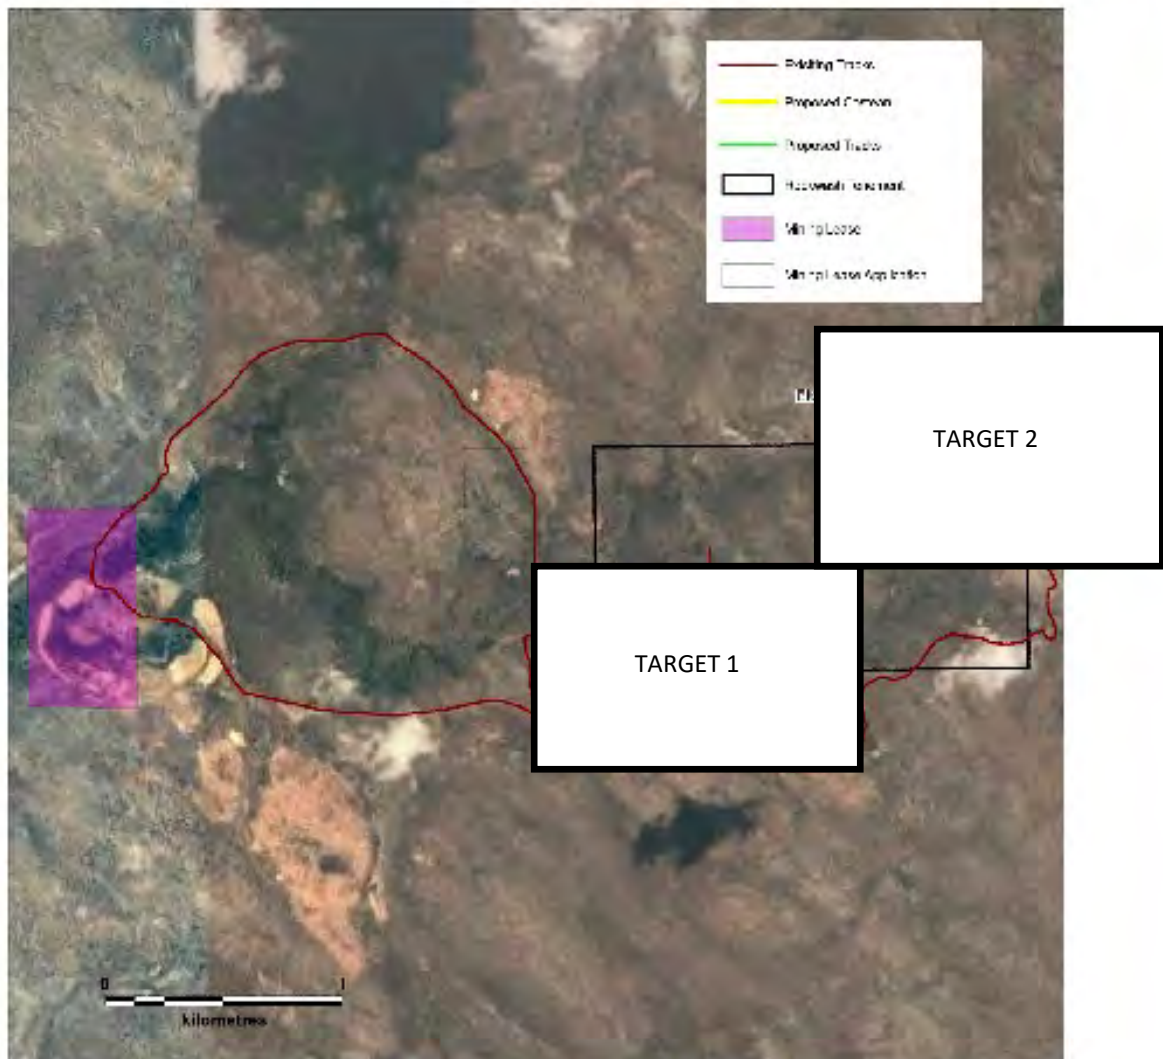
Figure 10 Proposed Tracks and Costeans on EL31524 (East Side)

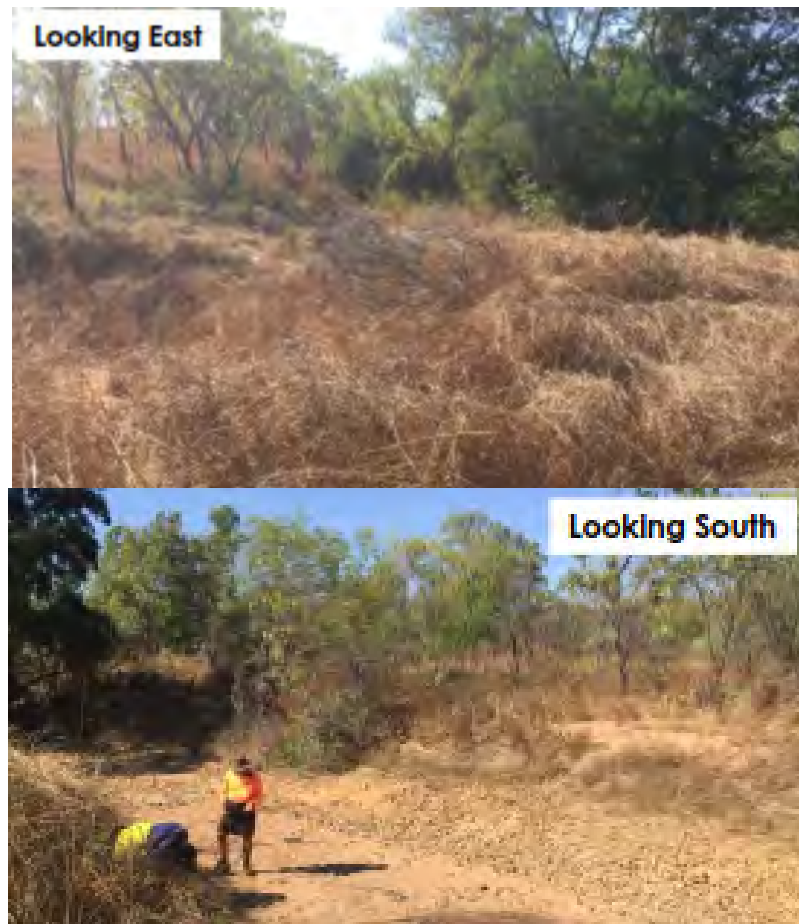
Generally, the topography of the tenement areas consists of undulating terrain with scattered hills, isolated strike ridges and alluvial flats. The hill slopes and summits consist of erosional remnants of siltstone, sandstone and quartz on slightly weathered meta- sediments of the Burrell Creek geological formation. Colluvial wash slopes have a veneer of siltstone flakes and/or sub-angular stony quartz in a loamy mix. Soils are either gravelly or skeletal on the slopes and summits or silty, sand or clay soils on the flats. The Figures below show the 1:250K geology and topography and the air photo imagery (google earth) over the tenements.

Figure 12 Representative photographs of land type/forms and topography on EL31276.

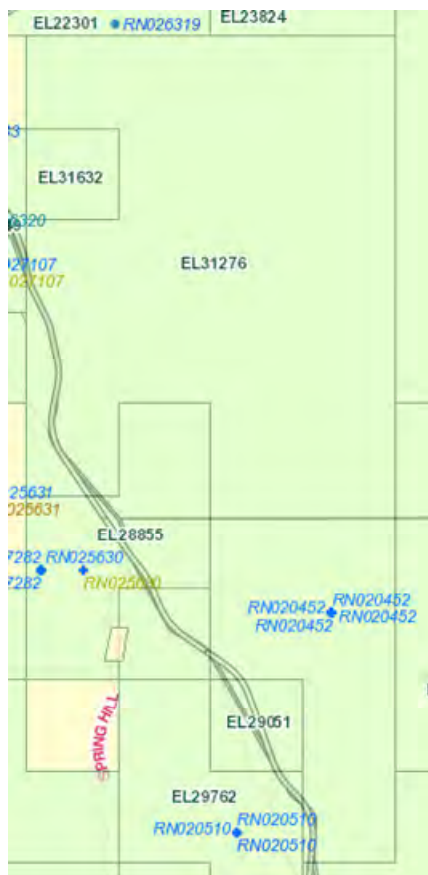
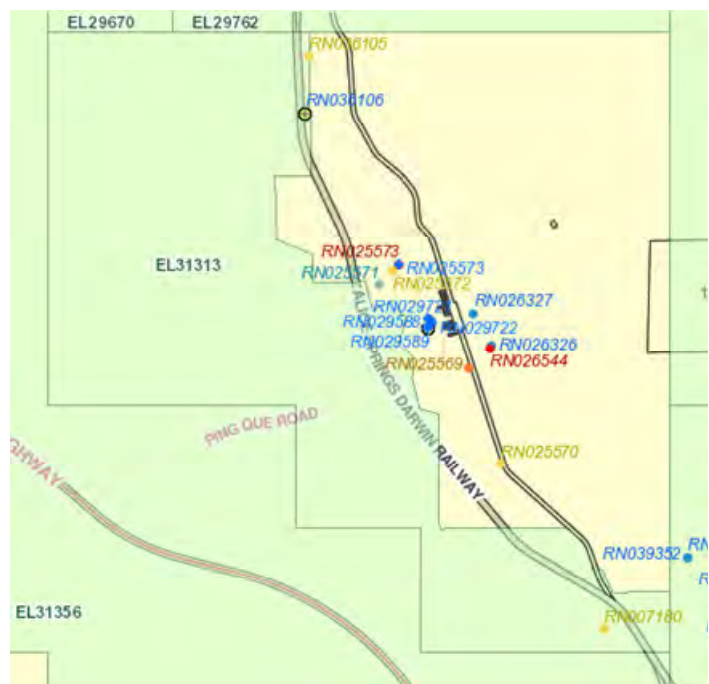
**Figure 16 Bore hole locations around EL31276, EL31632 and EL31313. Bore locations shown as dots, tenement boundaries shown as green polygons.**

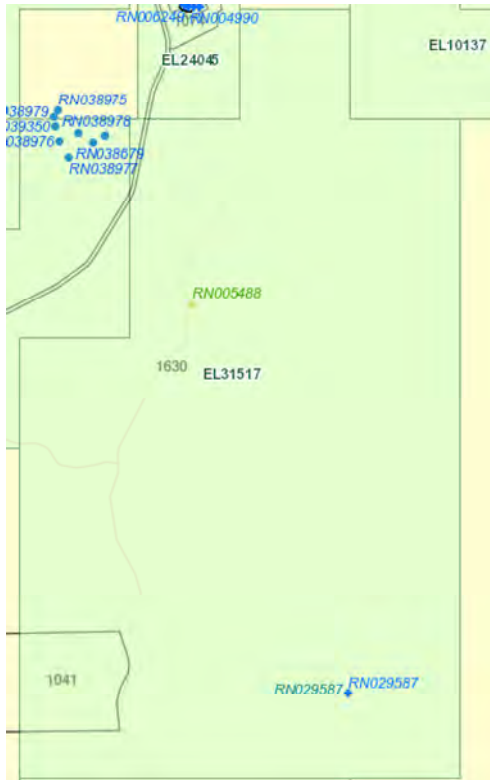
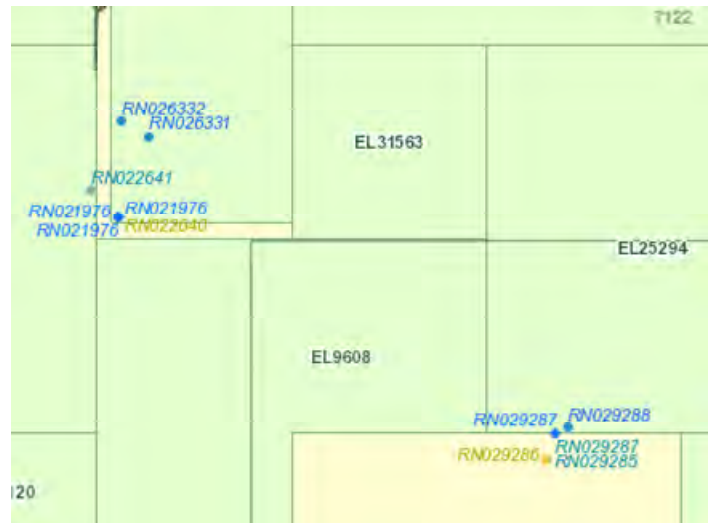
**Figure 17 Bore hole locations around EL31517 and EL31563. Bore locations shown as dots, tenement boundaries shown as green polygons.**

EL31517: RN029587 incorrect location, RN005488 standing water level at 18.8m, water quality noted as good.

EL31563: No bores in tenement, nearby bore to the east RN026332 for Mount Bonnie mine processing gave standing water level at 3.8m no quality data reported. RN022640 drilled to supply water to the mine dam struck first water supply at 21m.
